Inspection and Maintenance of Rails in Relatively High Slope Region of Thailand

- 1. Mechanical Properties and Microstructure of Rail Steels
- 2. Corrosion map for rail tracks and fastening system
- 3. Failure Analysis of Railways in Northen Line
- 4. Digital Platform for Rail Maintenance Database

Location for Case Study : Lampang Province in the Northern Region of Thailand.

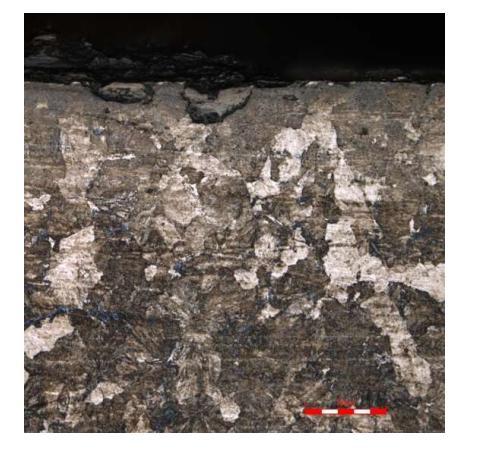
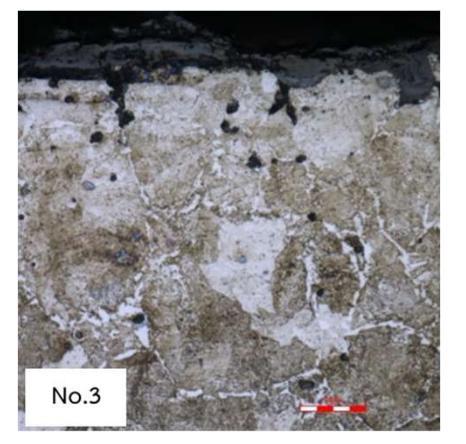
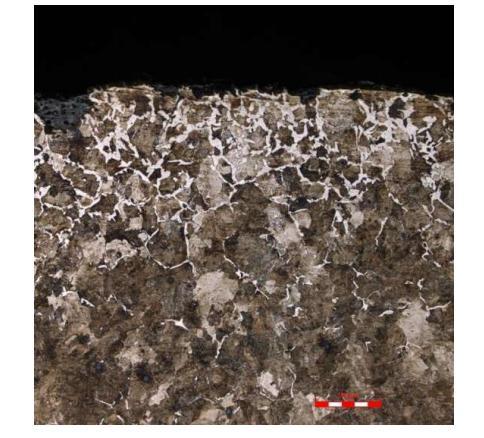
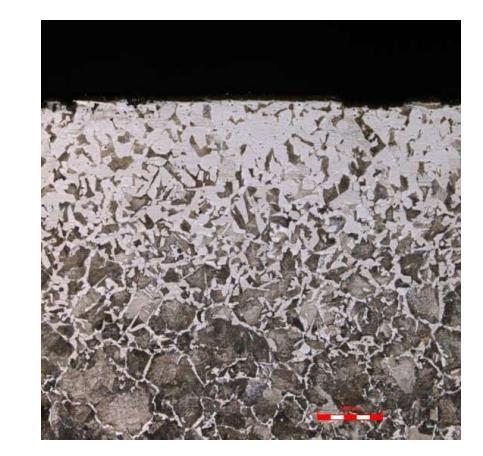
Corrosion and decarburization were observed on the running surface

- Corrosion pits on the contact surface could act as a stress concentrator and can be the starting point for cracks, especially under cyclic loads.
- A decarburized layer with a ferrite network was found at the contact surface.
- EN 13674: The maximum amount of decarburization allowed on rail, defined as a complete ferrite network at the surface, is 0.5mm.
- Therefore, there should be storage requirements, such as a roof or a rust-proof coating, etc., and the degraded layer removed.

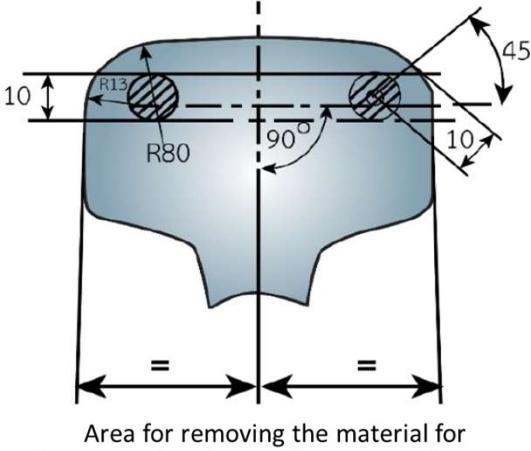
Cross-section of the rail head showing the areas for preparing tensile strength and microstructure test samples (in mm) designed by SRT. It should be redesigned to cover the contact surface.

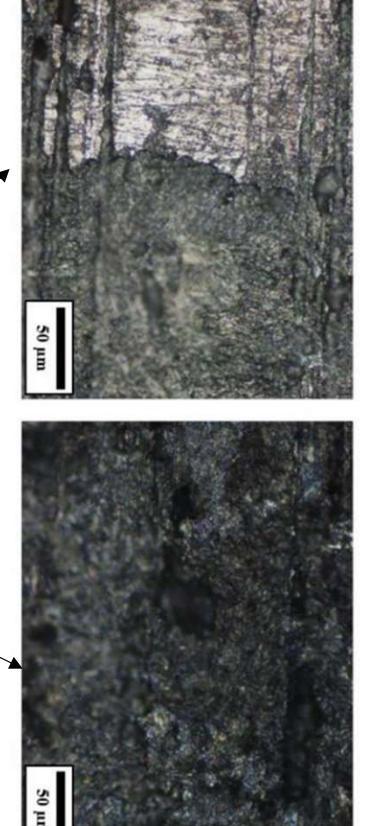
Severe corrosion inside the crevice area

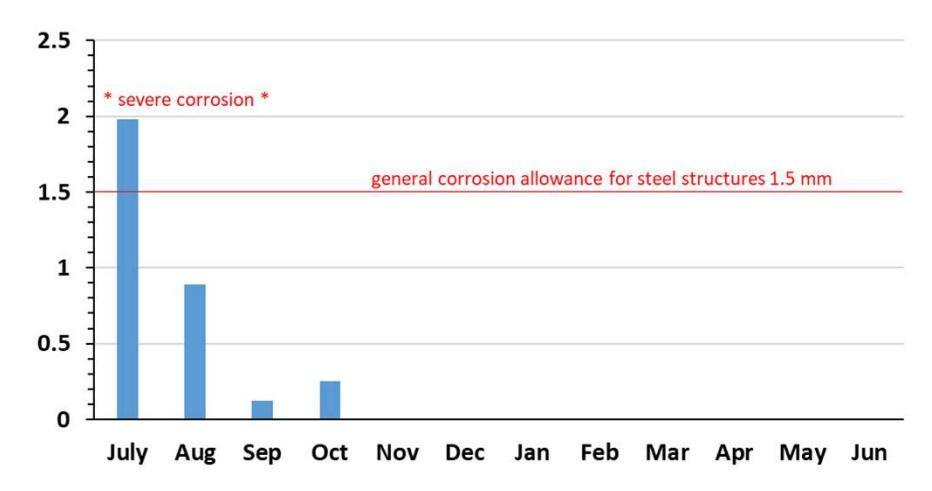
Average crevice corrosion rate for 4 months was **30X** faster than general corrosion rate in marine test site.

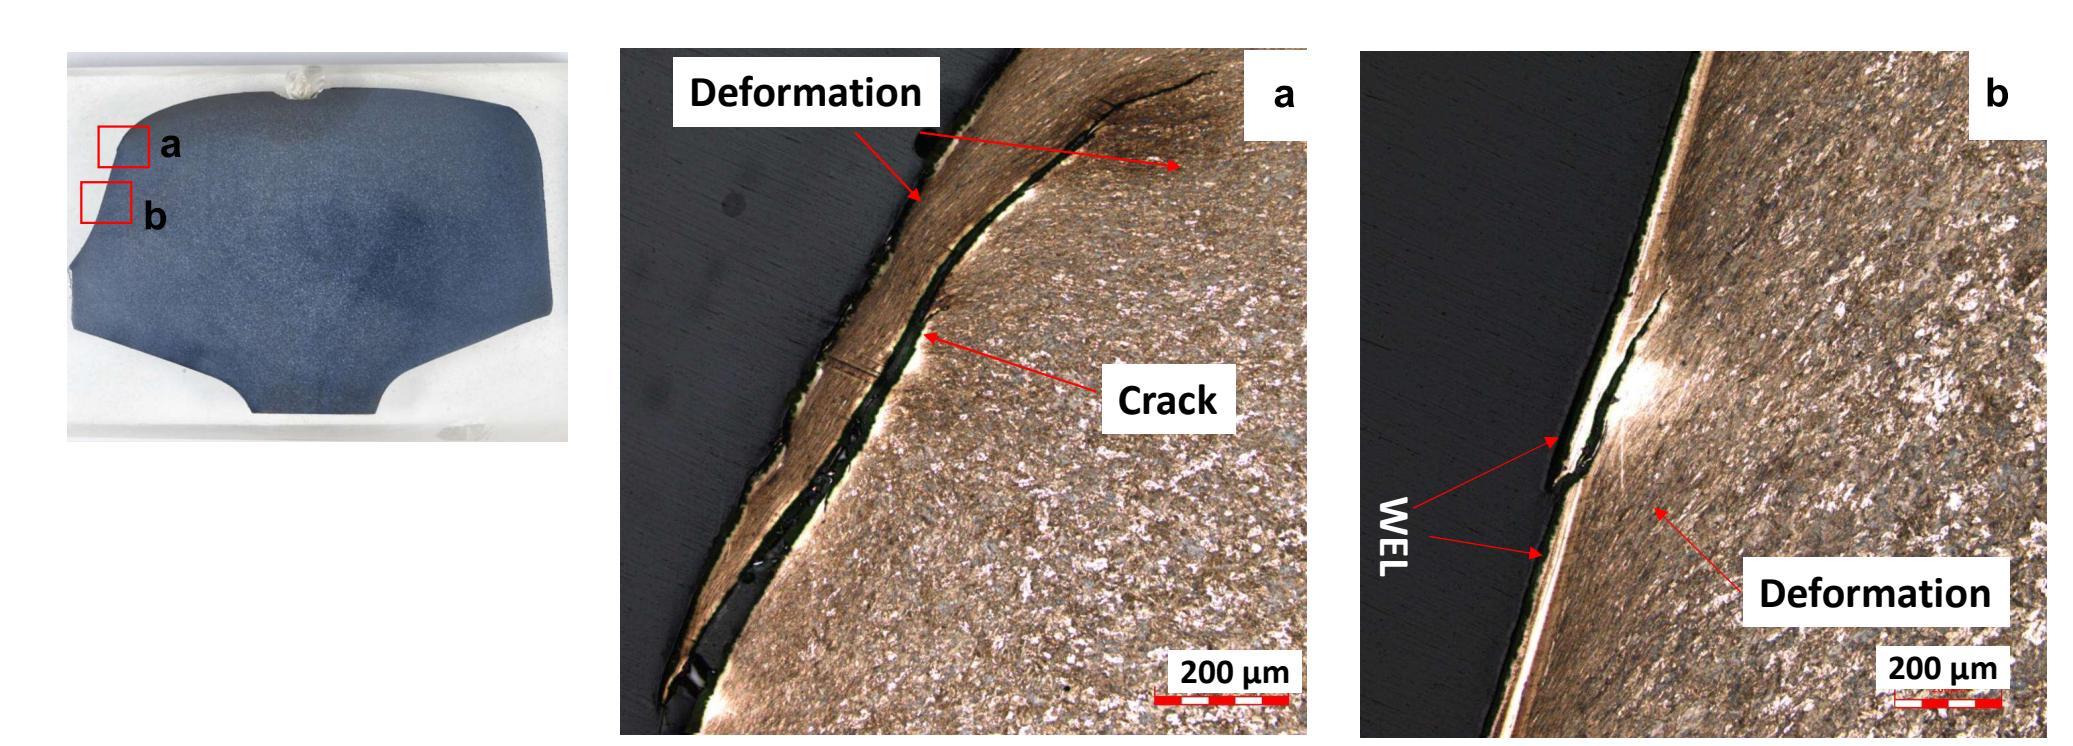
At gauge side near the rail head, (White Etching Layer: WEL), cracks and materials deformation were found.

- The location where severe wear occurs on the gauge side is typically the point of contact between the wheel and the rail.
- Deformation and WEL, high hardness phase was found at wear area.
- Crack initiated at deformation area and crack propagated along ferrite phase

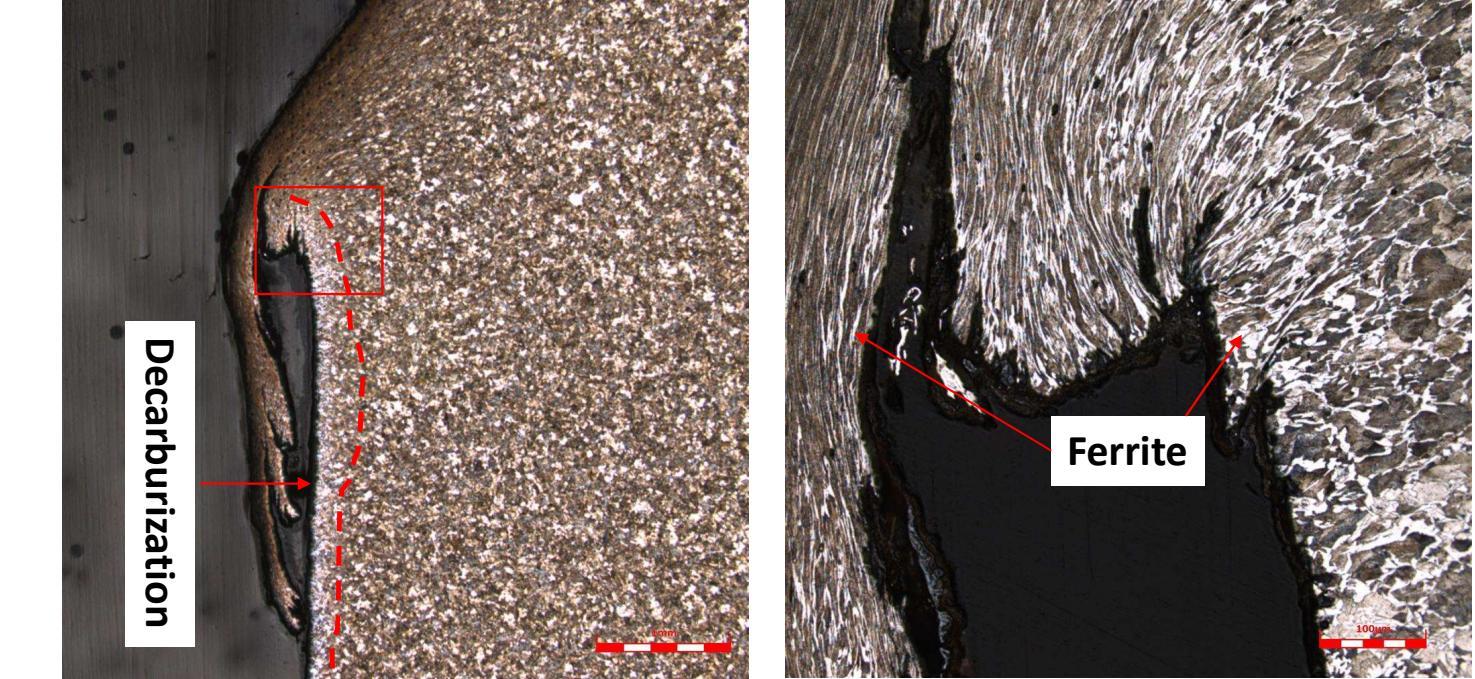
At position c, cracks were found at decarburization area. Crack propagated along ferrite phase.

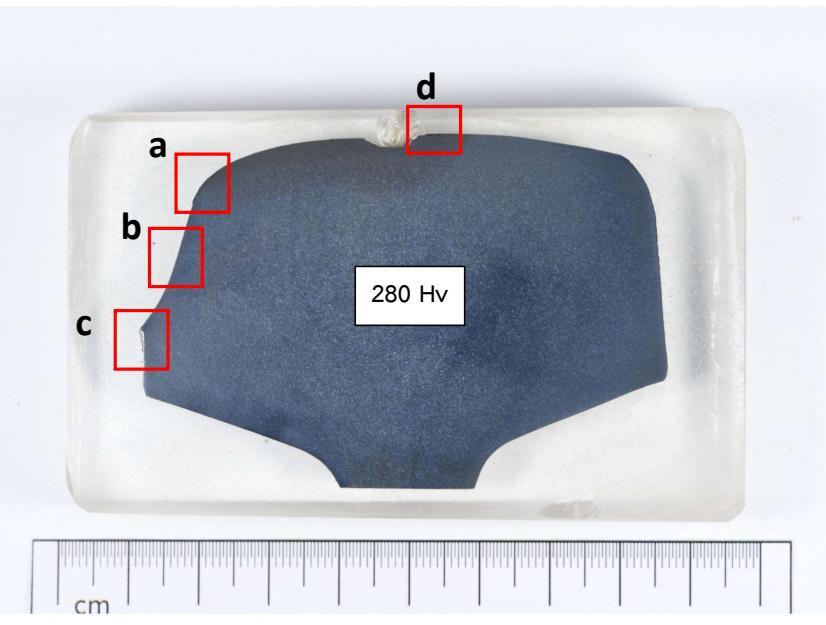
Hardness at deformation area and WEL higher than normal area.

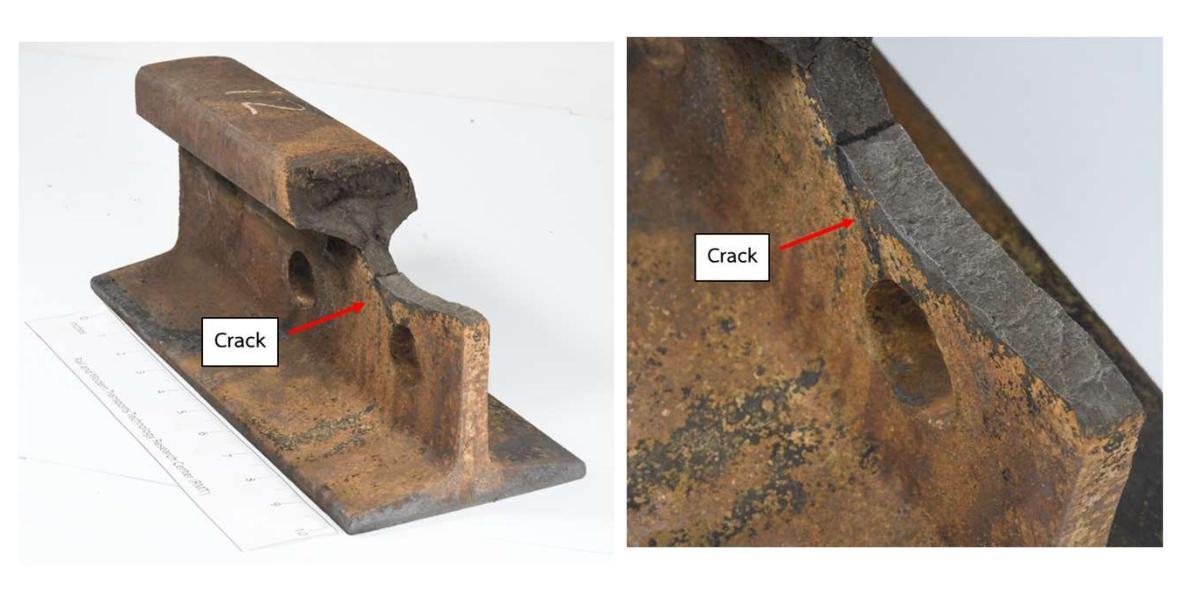
Sample #3

Deformation was found at fish plate hole

- Crack initiated from fish plate hole.
- Deformation was found at fish plate hole.
- Hardness at crack origin and deformation area higher than UIC 900A standard.

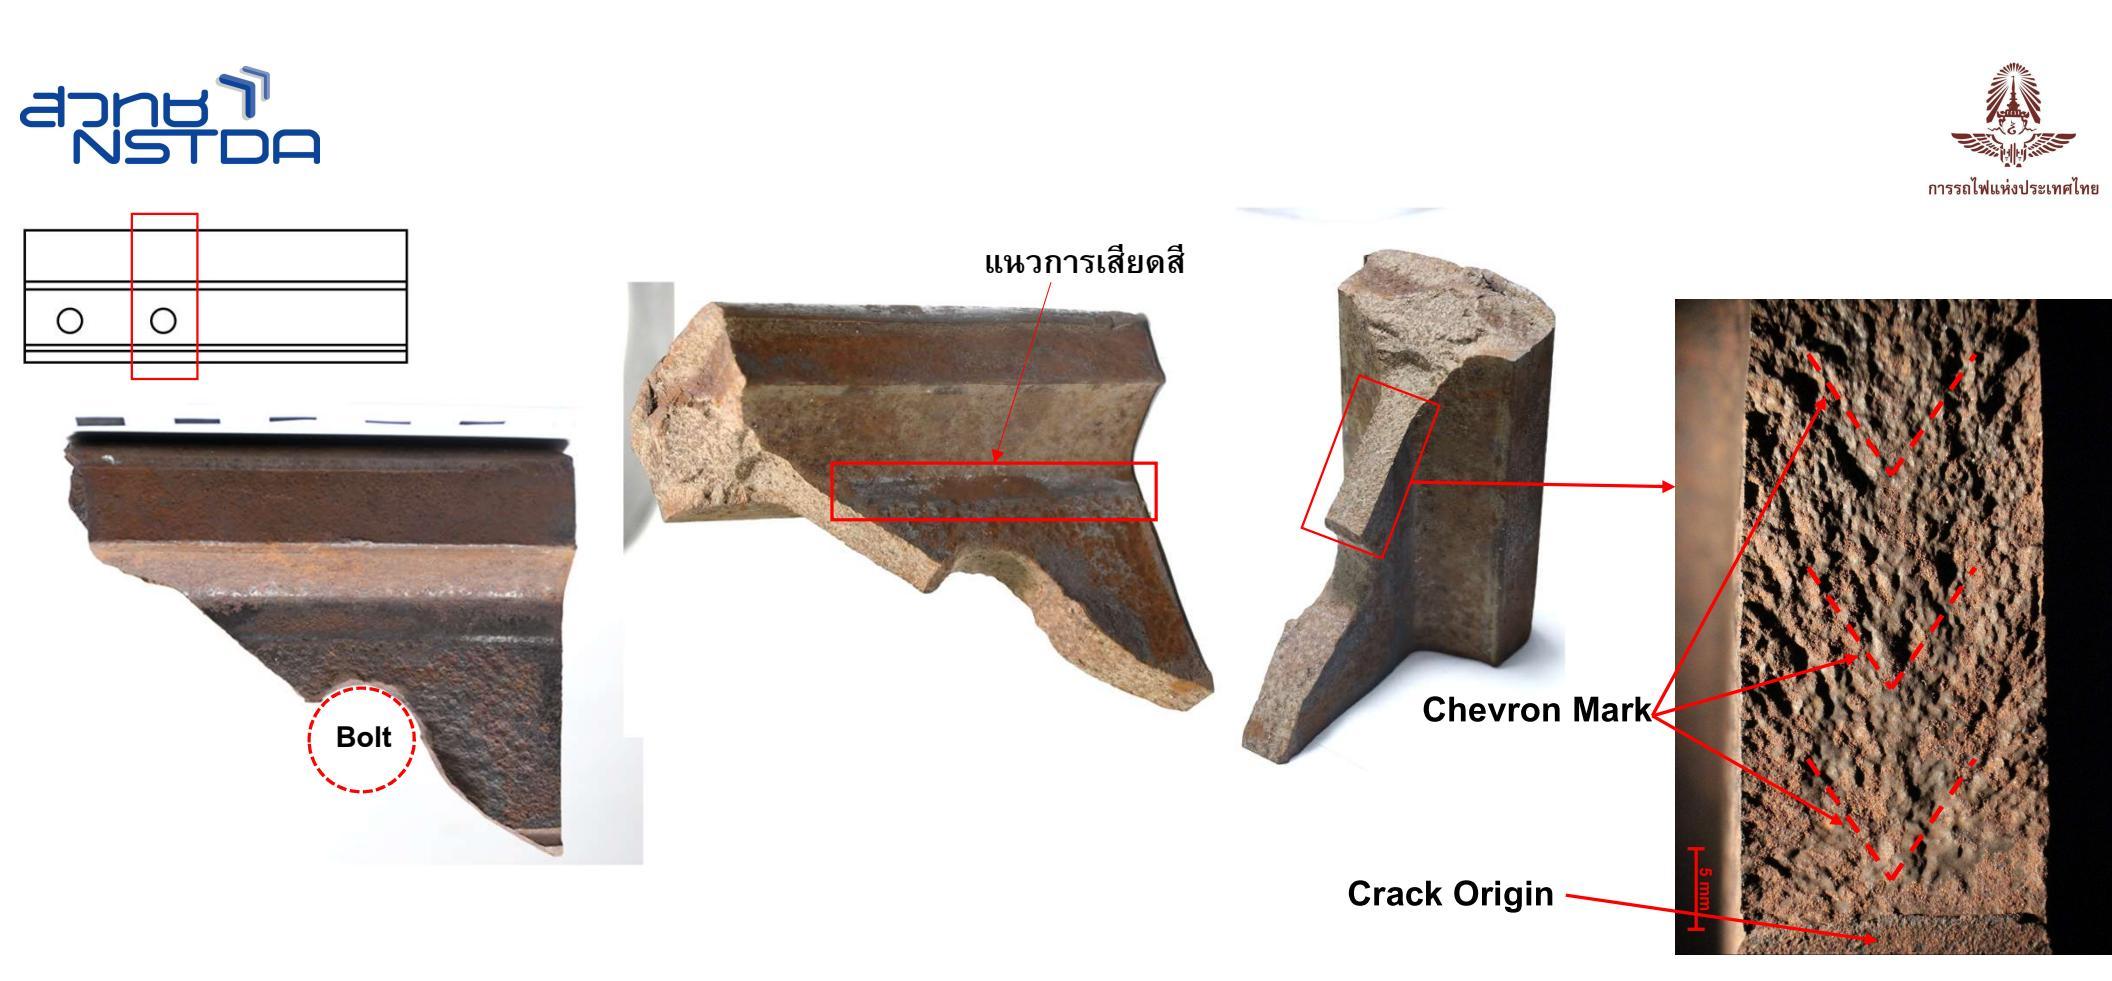
Chevron marks indicated that crack initiated from fish plate hole

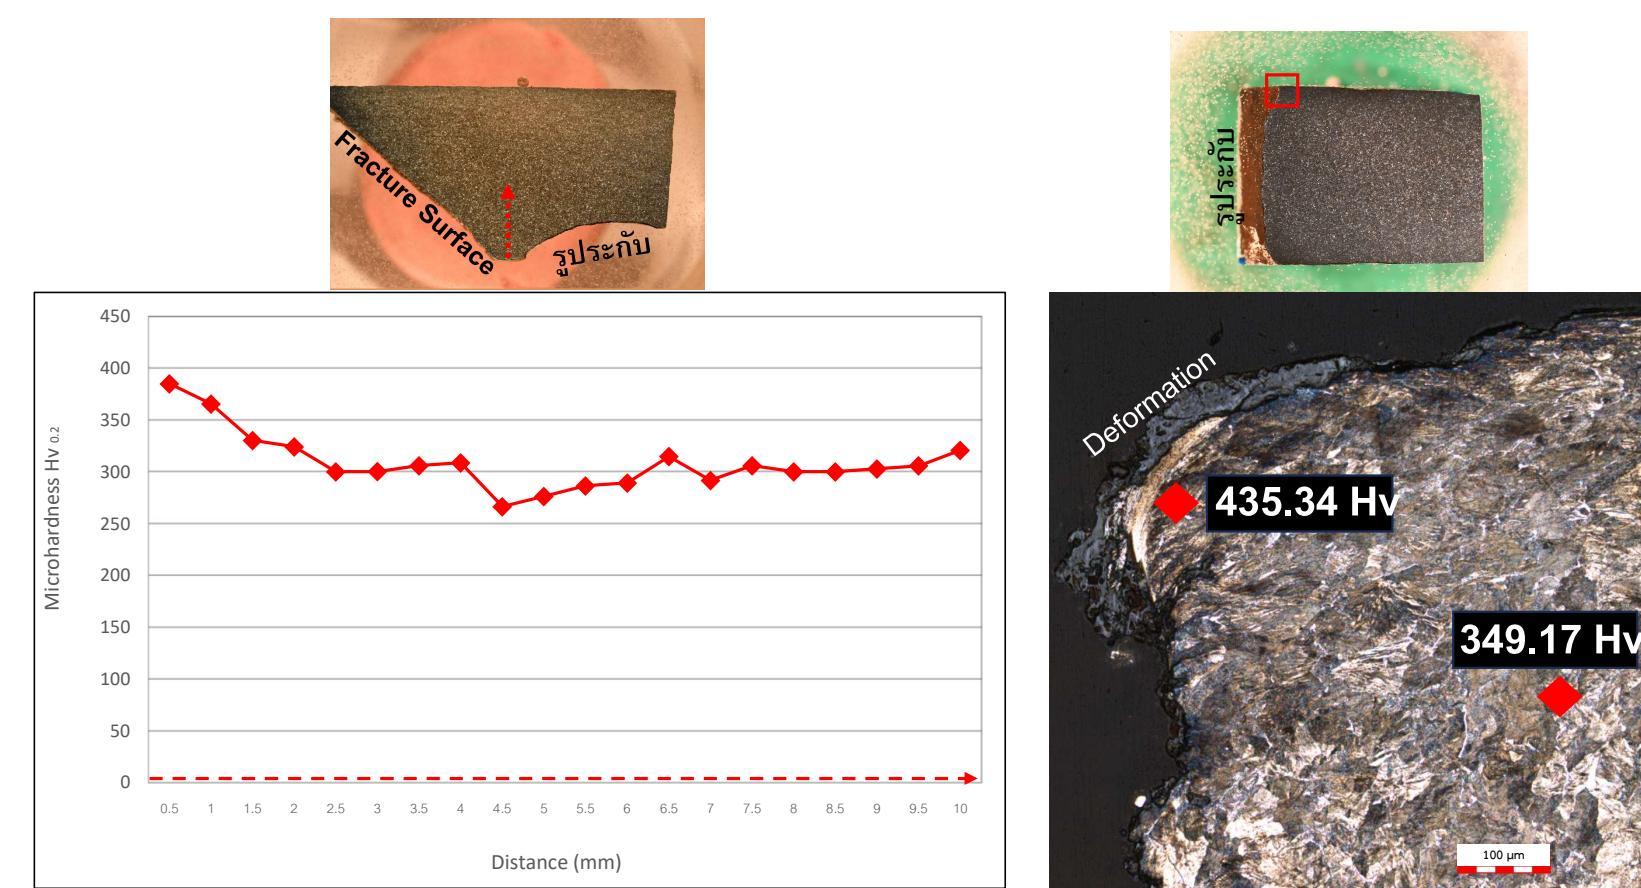
Hardness at crack origin and deformation area higher than UIC 900A standard.
