Inspection and Maintenance of Rails in Relatively High Slope Region of Thailand

- 1. Mechanical Properties and Microstructure of Rail Steels
- 2. Corrosion map for rail tracks and fastening system
- 3. Failure Analysis of Railways in Northen Line
- 4. Digital Platform for Rail Maintenance Database

Location for Case Study : Lampang Province in the Northern Region of Thailand.

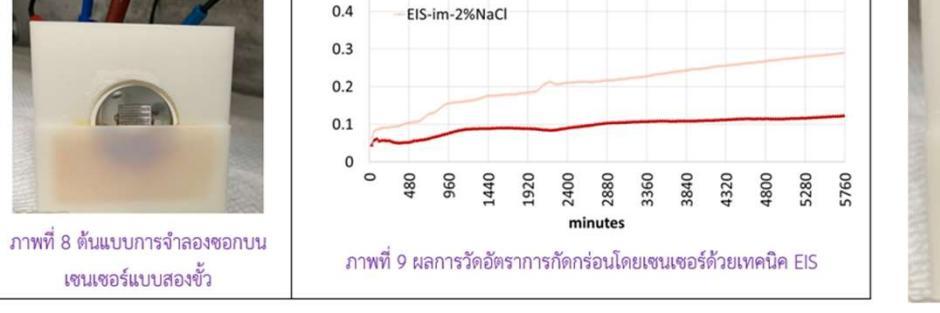
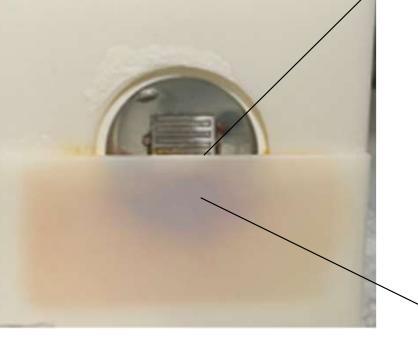
fill: fill the crevice with NaCl 2%wt solution (solution dry up) im: immerse sensor in NaCl 2%wt solution (always in contact with NaCl)

Corrosion rate of fill = 0.5 x (corrosion rate of im)

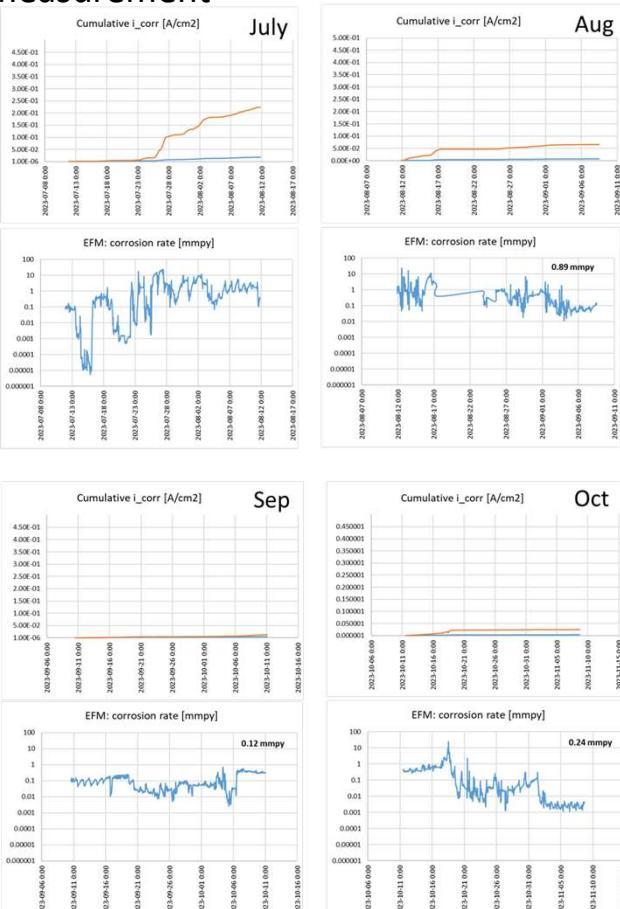
Mae Jang Station

Corrosion current density (I corr) and corrosion rate from EIS measurement

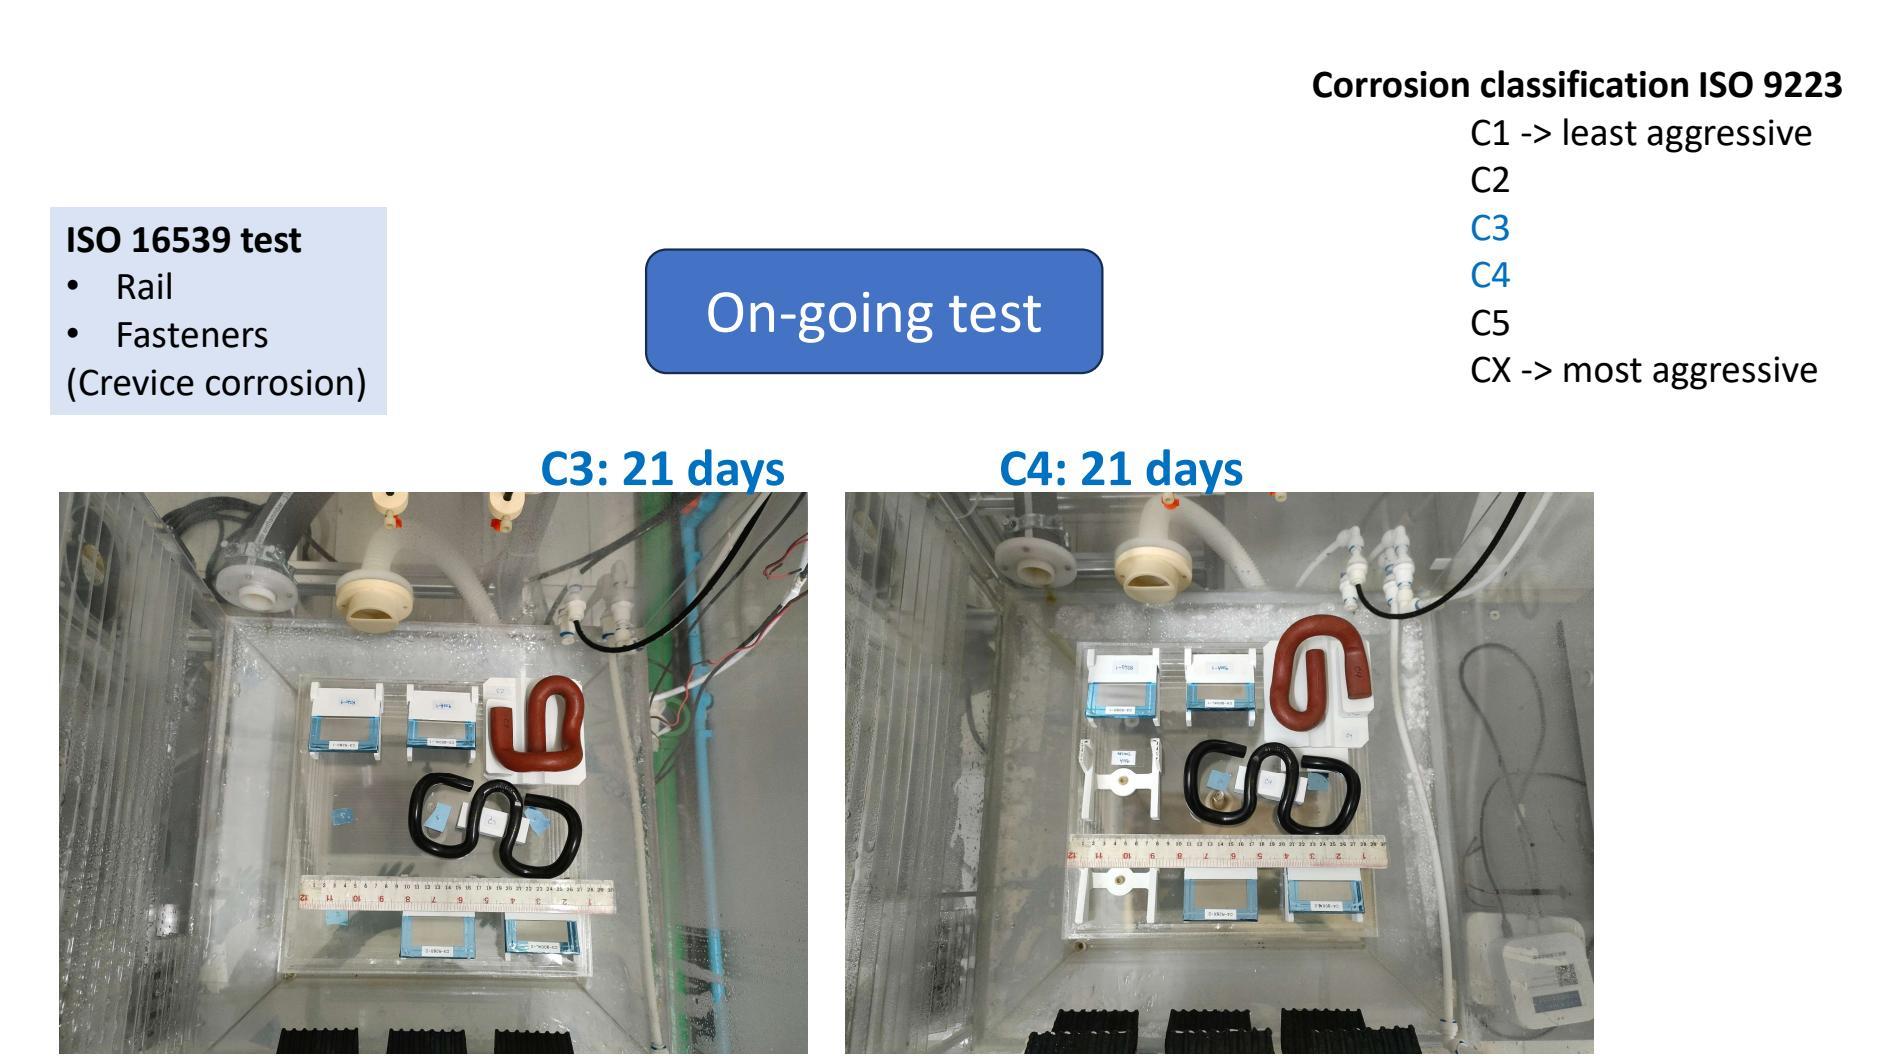
Average crevice corrosion rate for 4 months was **30X** faster than general corrosion rate in marine test site.

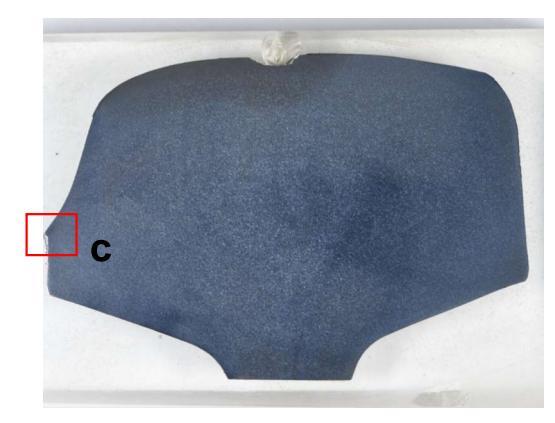
At gauge side near the rail head, (White Etching Layer: WEL), cracks and materials deformation were found.

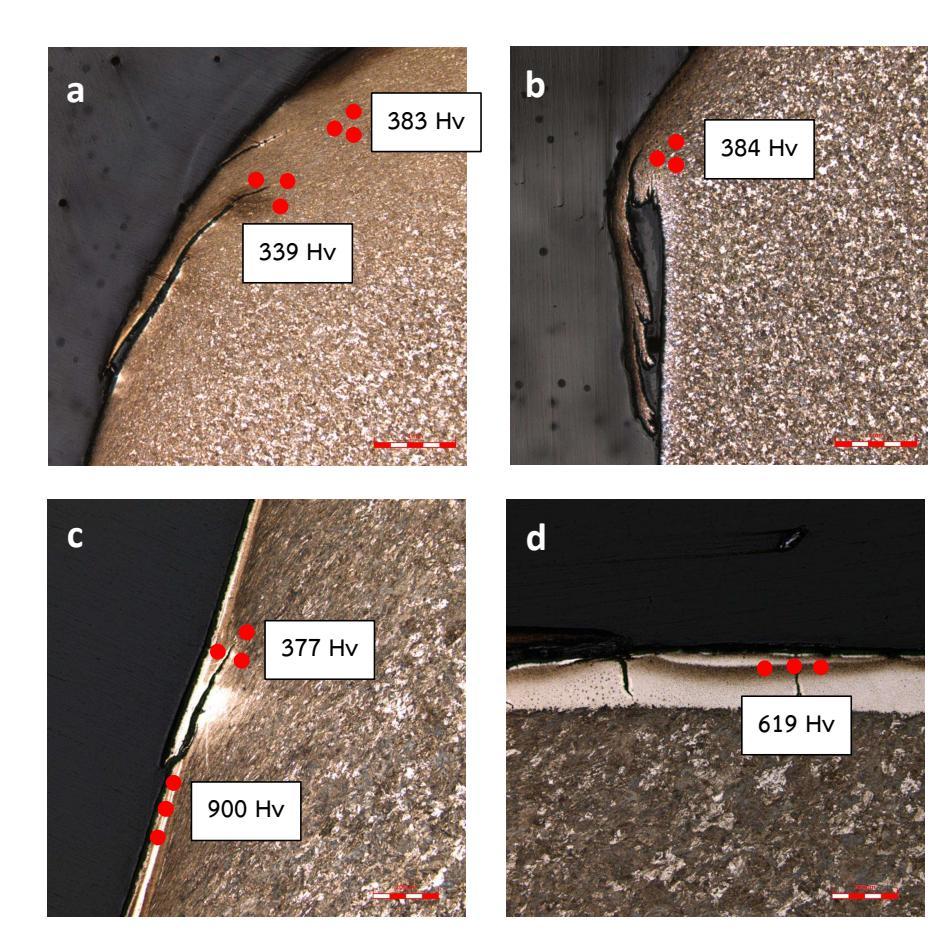
Hardness at deformation area and WEL higher than normal area.

- The location where severe wear occurs on the gauge side is typically the point of contact between the wheel and the rail.
- Deformation and WEL, high hardness phase was found at wear area.
- Crack initiated at deformation area and crack propagated along ferrite phase

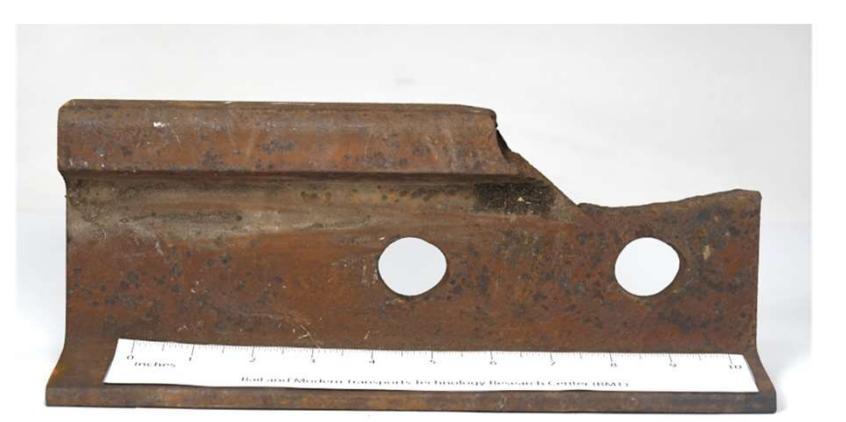
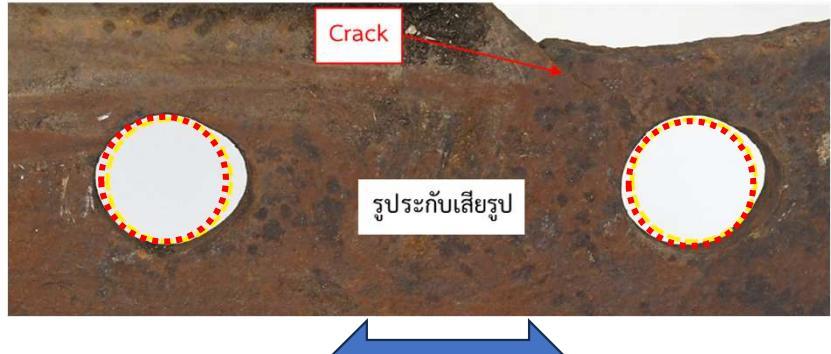
Sample #3

Deformation was found at fish plate hole

- Crack initiated from fish plate hole.
- Deformation was found at fish plate hole.
- Hardness at crack origin and deformation area higher than UIC 900A standard.

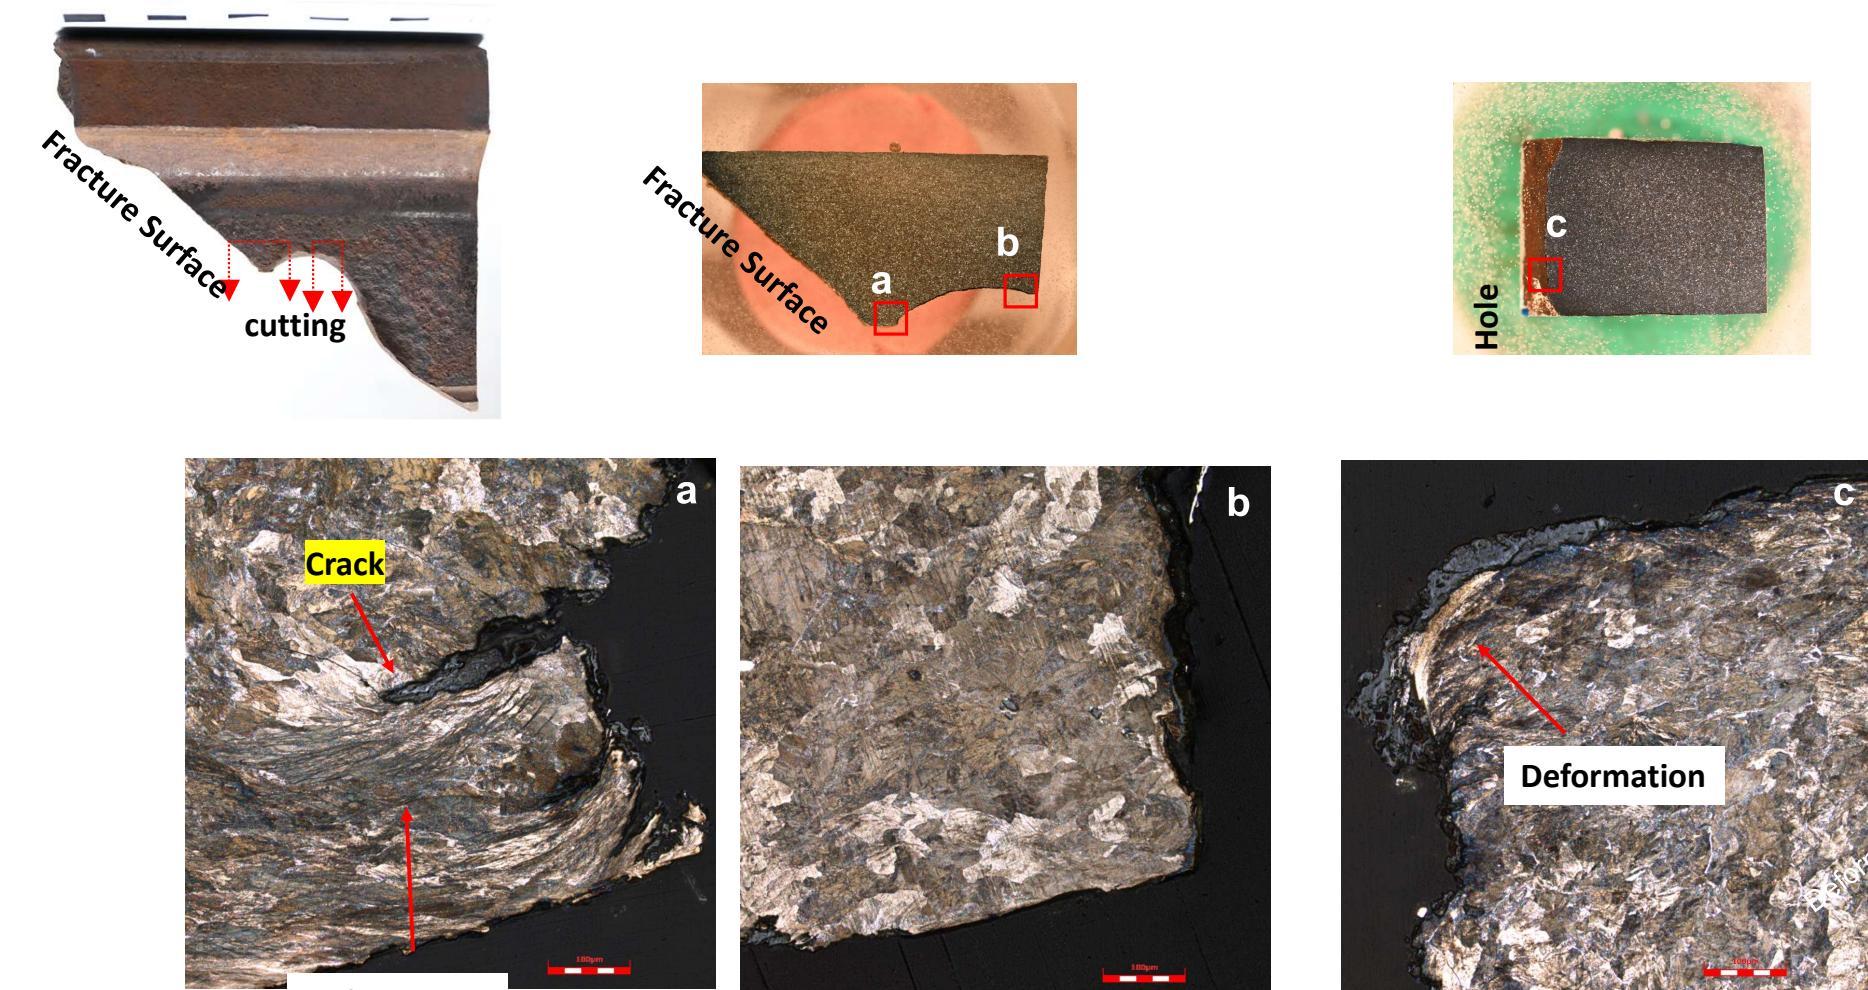
Chevron marks indicated that crack initiated from fish plate hole

Hardness at crack origin and deformation area higher than UIC 900A standard.
